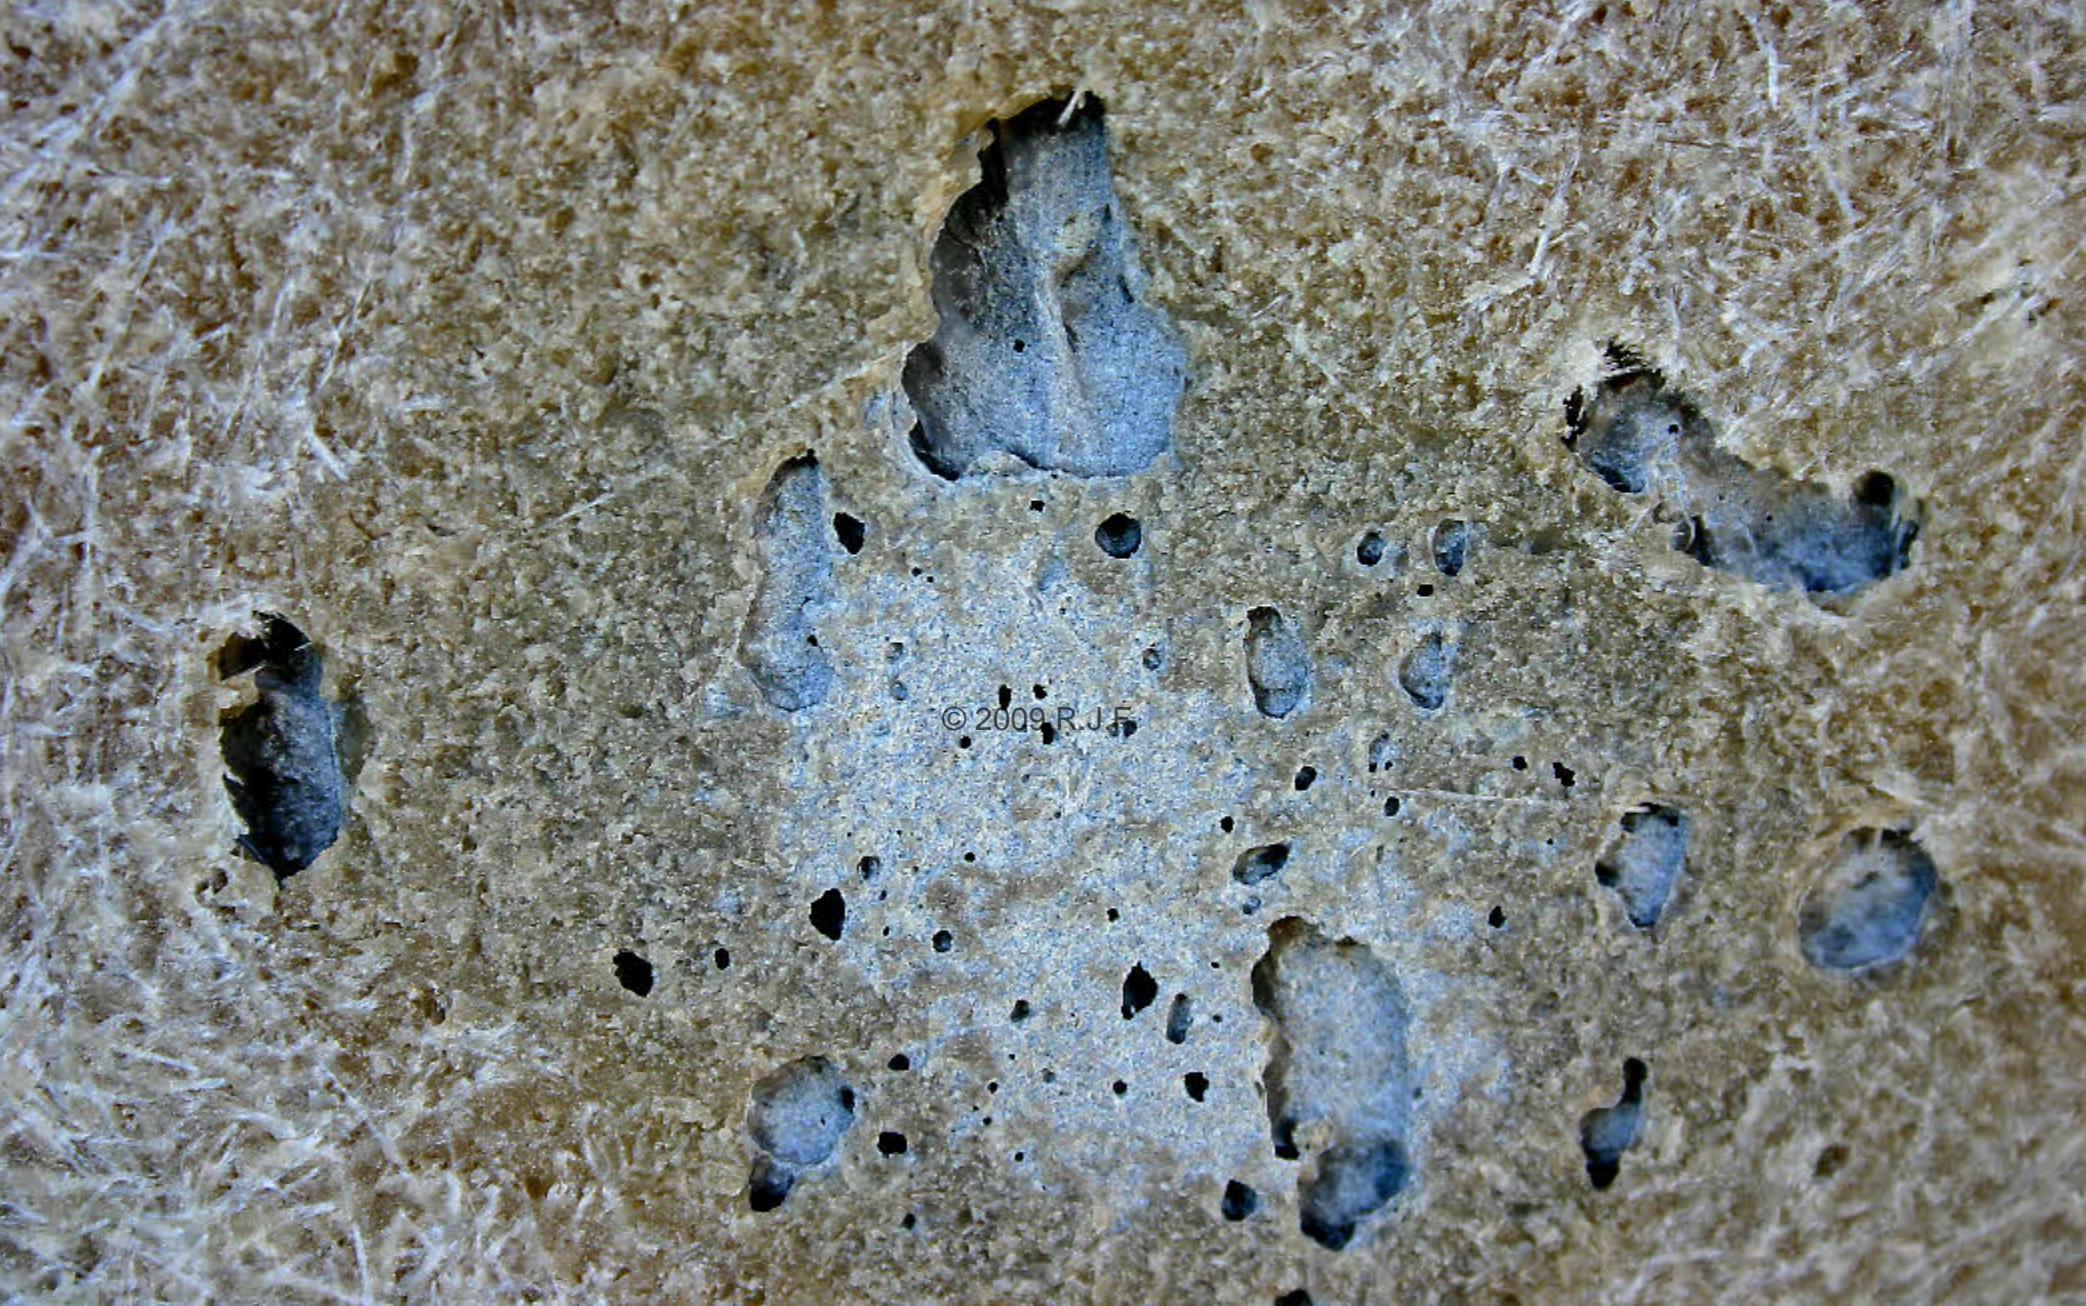
These cavities in the laminate are due to poor laminating practice during moulding. They were exposed during peeling and shot blasting and will need to be filled with Easy Fair filler after the application of 1 coat of SAFEGUARD LVP
