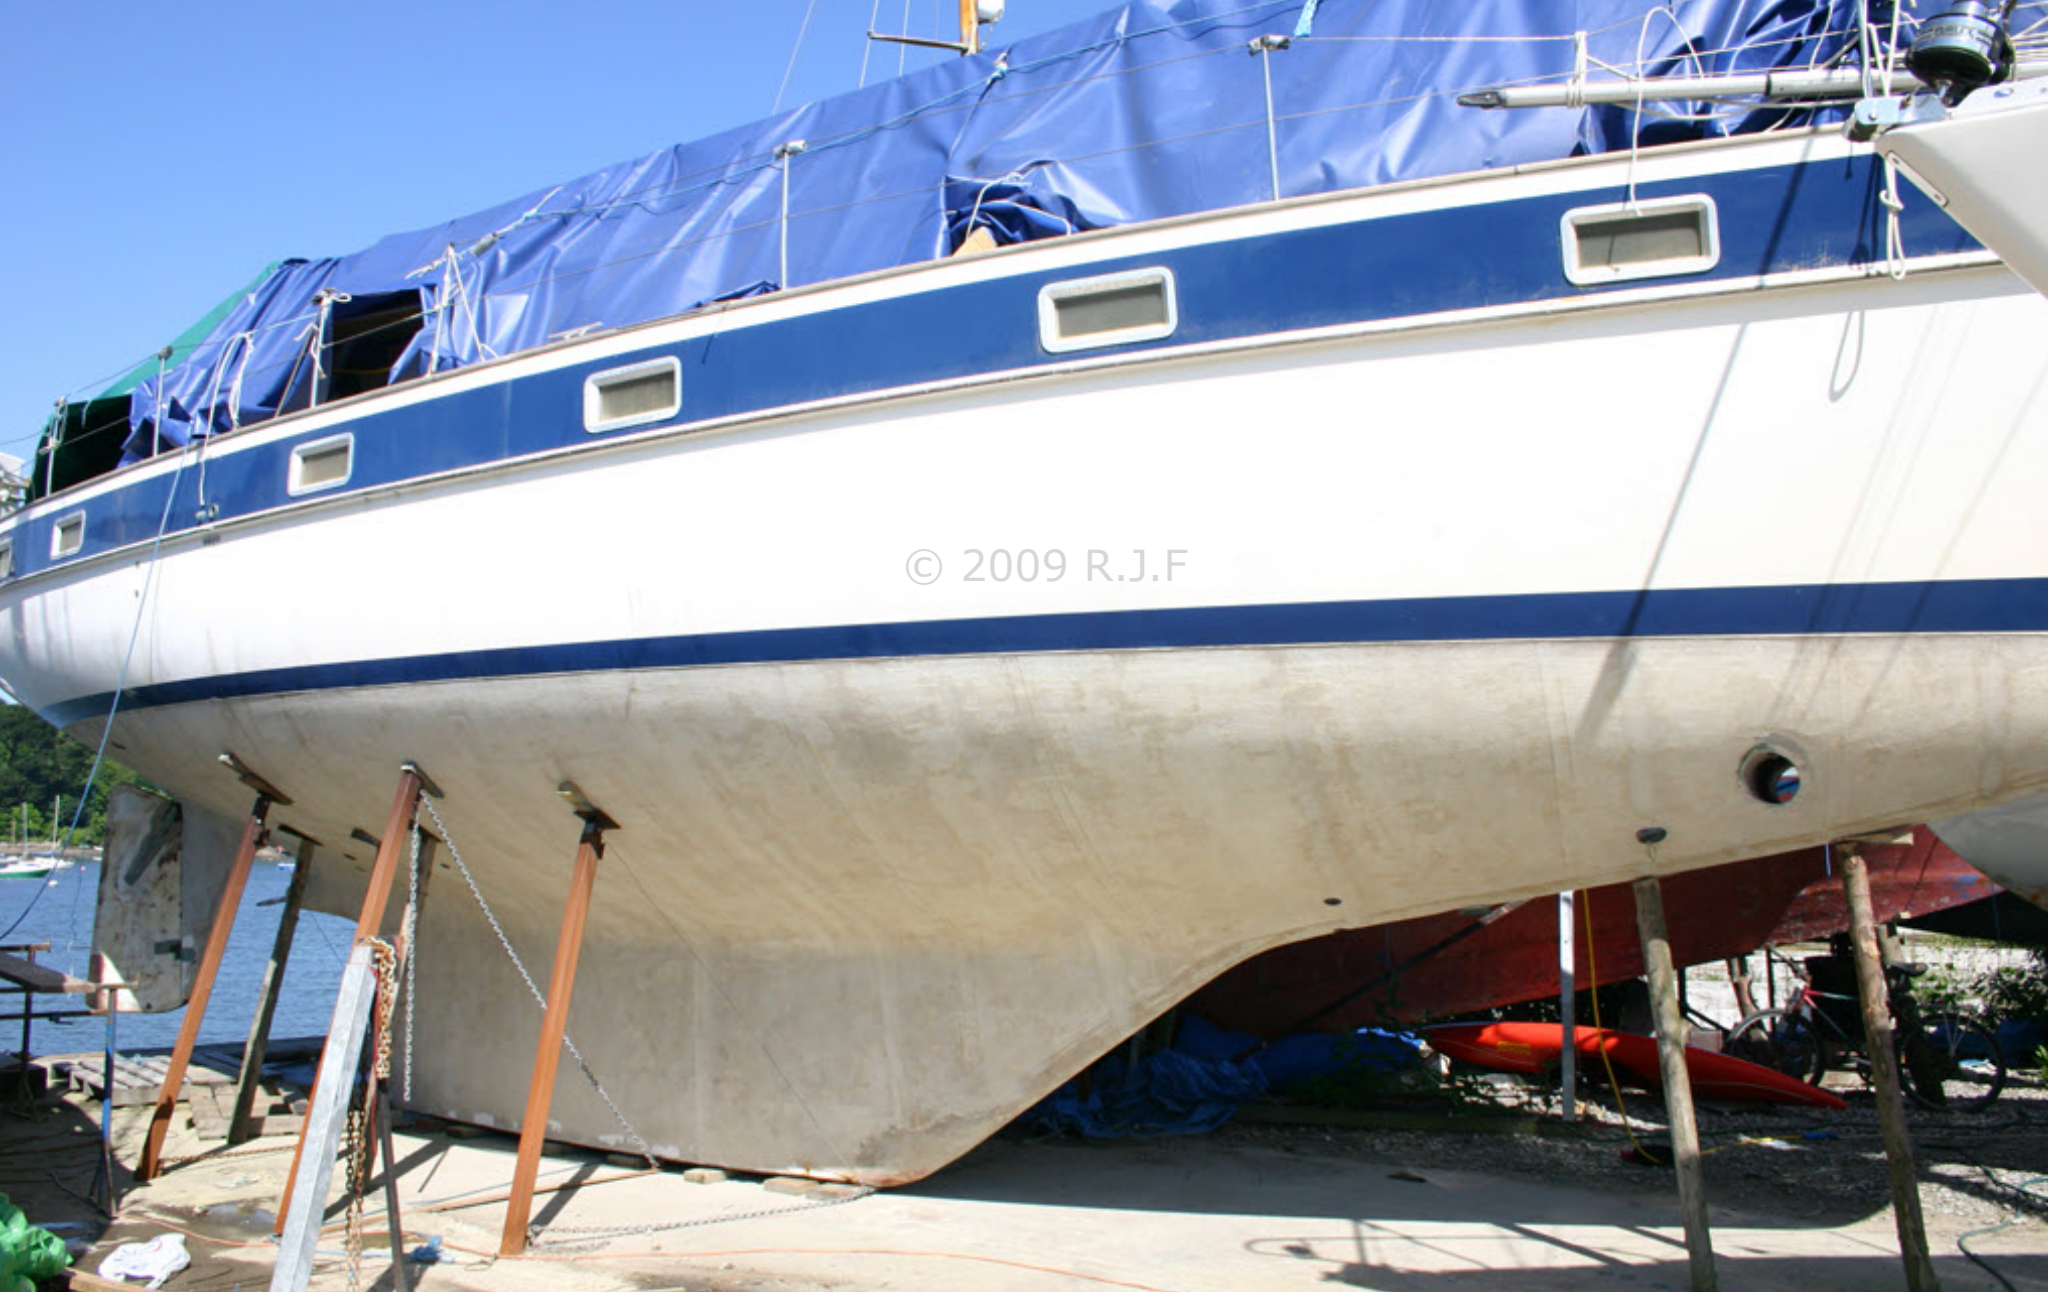
This yacht has been peeled, sand blasted, hot pressure washed, dried and coated with SAFEGUARD LVP and faired with EASY FAIR TROWEL-ABLE filler. After this photograph was taken one coat of SAFEGUARD PS, 5 coats of SAFEGUARD TSF 1 coat of EASY FAIR SEU. and 2 coats of COPPERPLUS were applied
